NATIONAL PROGRAM FOR INSPECTION OF NON-FEDERAL DAMS
HILLINANTIC RESERVOIR... (U) CORPS OF ENGINEERS WALTHAM
MA NEW ENGLAND DIV JUN 79

4. TITLE (and Subtitle) Willimantic Reservoir Dam NATIONAL PROGRAM FOR INSPECTION OF NON-FEDERAL DAMS		5. TYPE OF REPORT & PERIOD COVERED INSPECTION REPORT

Willimantic Reservoir Dam - Overview Photo

PHASE I - INSPECTION REPORT

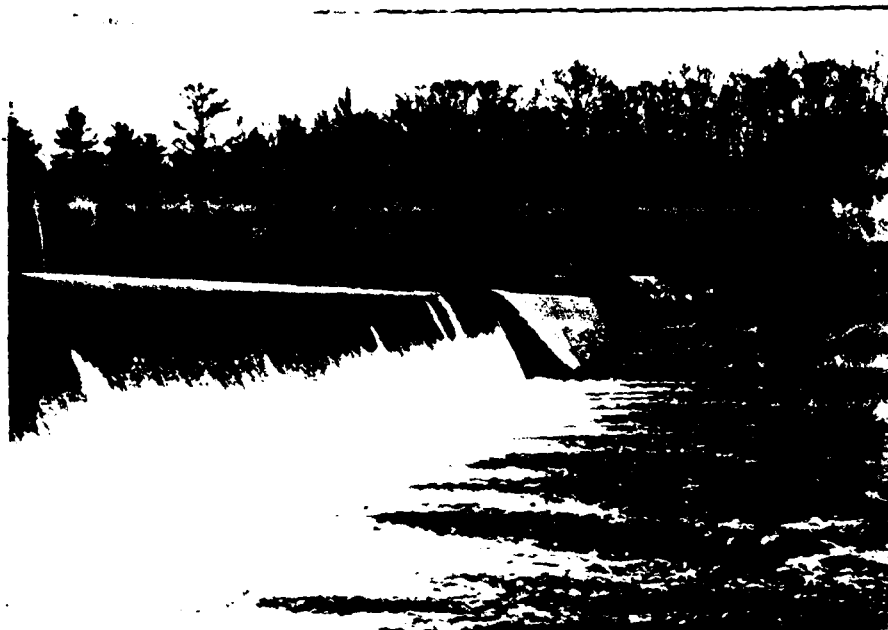
C-1 Downstream face of Dam looking from right abutment.

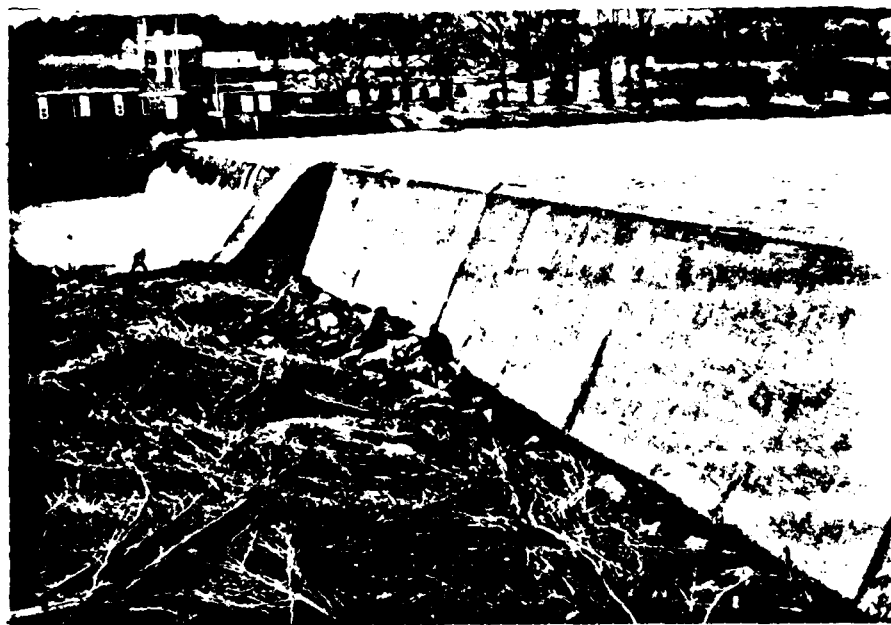
The downstream channel, shown in Photo C-2, appears to be in generally good condition. The left side of the downstream channel appears to have been recently cleared of vegetation as shown in Photo C-2. A pile of cut stone blocks was noted at the downstream toe of the left spillway section.

C-2 Downstream face of Dam looking from left abutment.

1. Develop a system for the recording of data with regard to items such as water levels, discharges, to assist those responsible for the monitoring and operation of the structure.
2. Implement a program to clear the discharge channel of vegetation in order to increase the efficiency of the outlet and removal of brush and trees piled downstream of the left section of spillway.
3. Continue the technical inspections of this facility on bi-annual basis.
4. Develop and post an emergency action plan including a warning system in order to prevent or minimize the impact of dam failure. It should include the expedient action to be taken, authorities to be contacted, and locations of emergency equipment and materials.
5. Repair all spalled concrete.

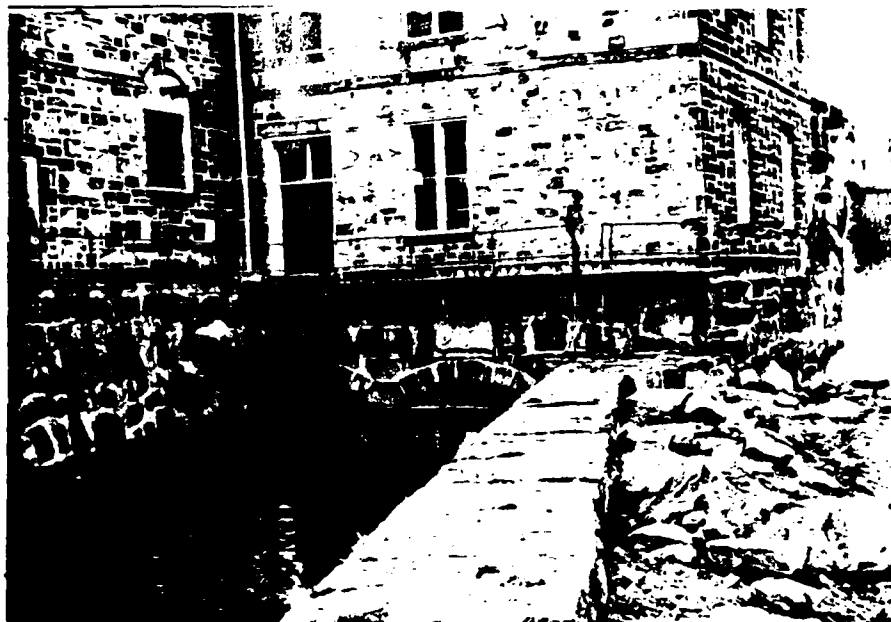
C-3 Pumping Station and Tailrace.

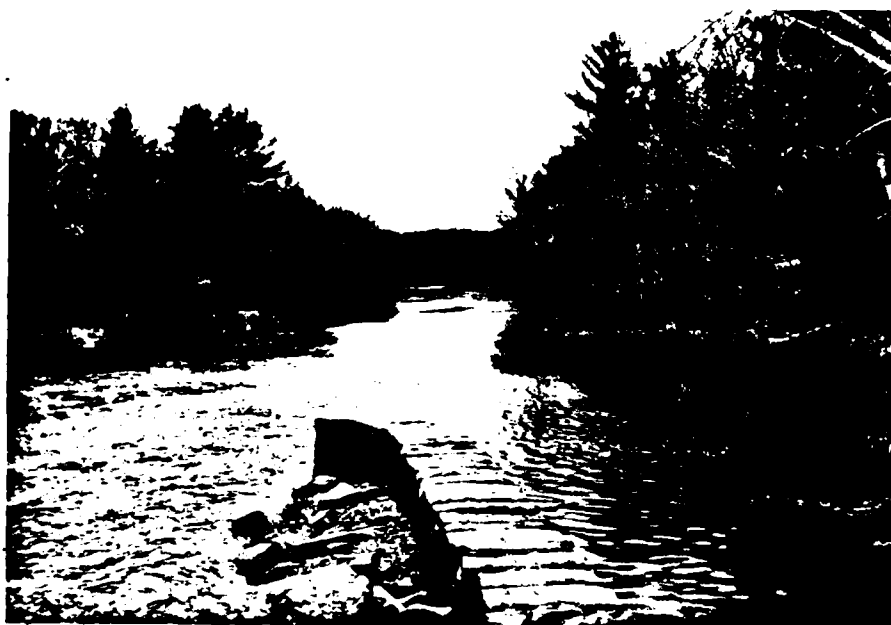
C-4 End of Pumping Station Tailrace and Nachaug River
Downstream.
